Damage investigation of timber structures by
The 2007 Noto Peninsula Earthquake

Kaori Fujita

Department of Architecture, The University of Tokyo

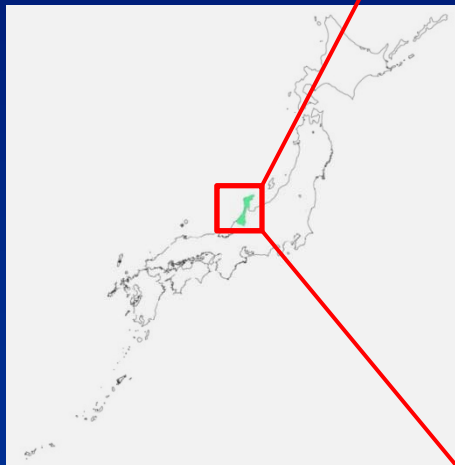
Outline of 2007 Noto Peninsula Earthquake

- 25th March, 2007
- Magnitude 6.9
- Off Noto Peninsula coast

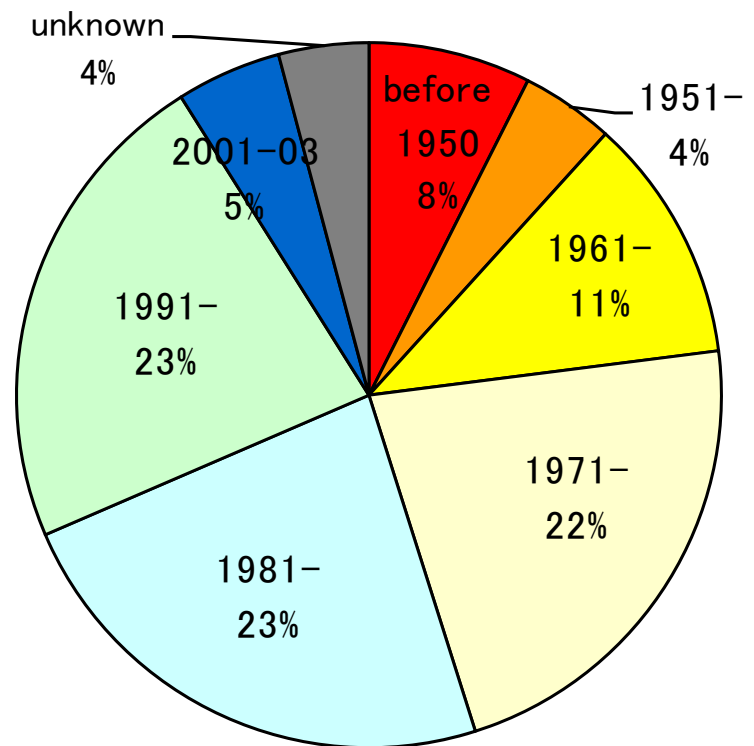
Construction Year of Existing Timber houses in Japan (28,759,000 units)

- Before 1950 : 8%
- Before 1980: 45%

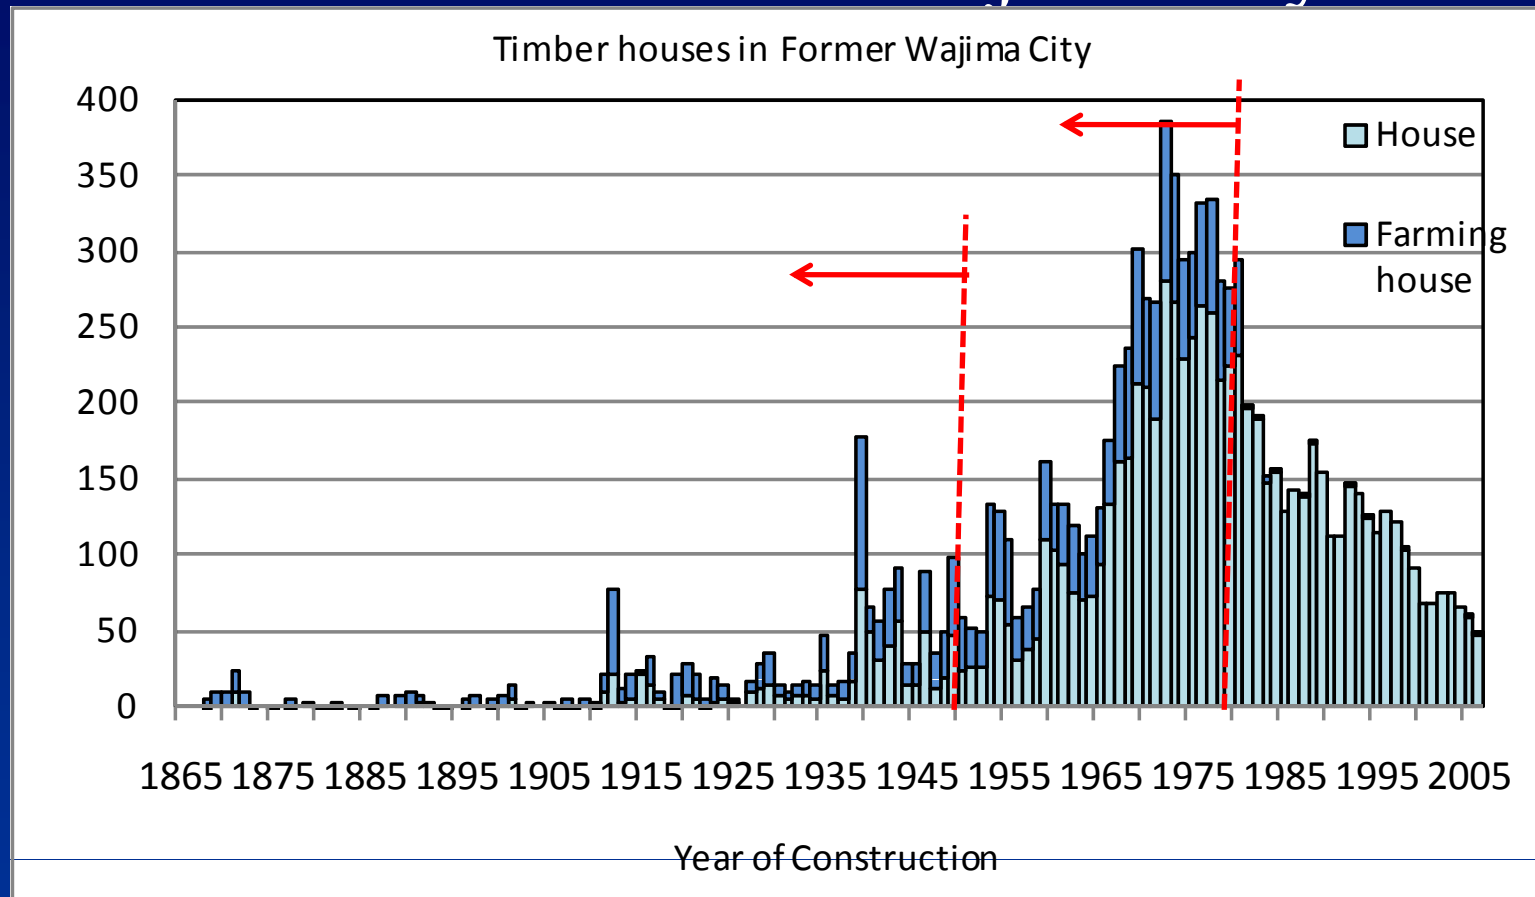
Distribution of construction year of timber houses in Wajima city

- Before 1950: 15%
- Before 1980: 70%

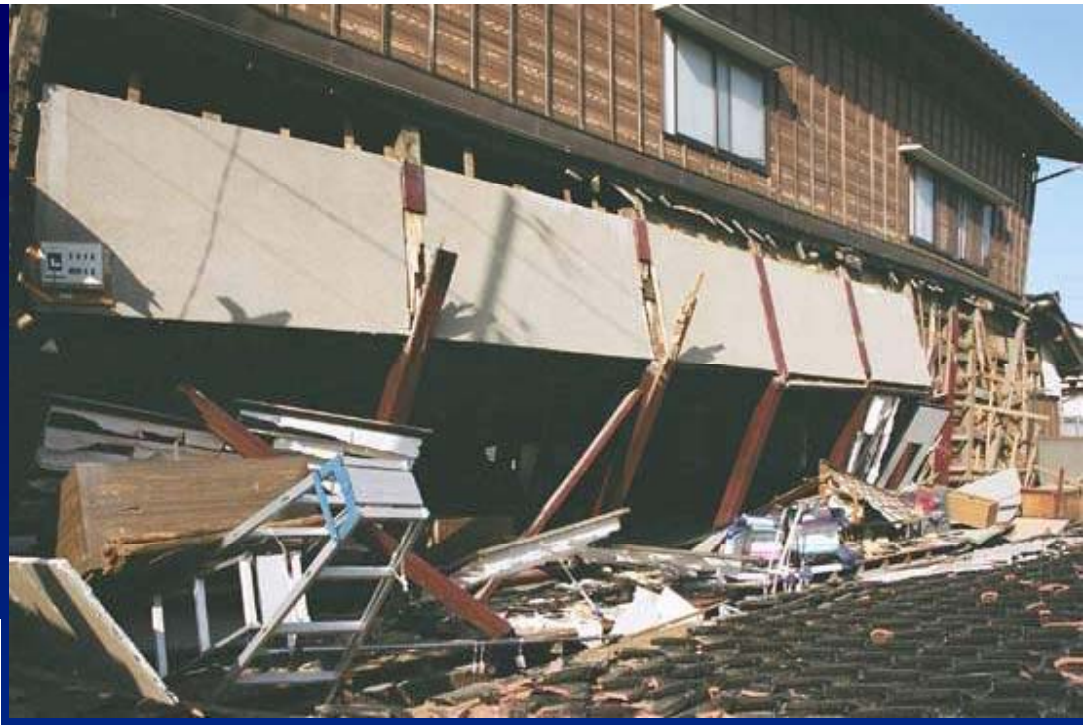
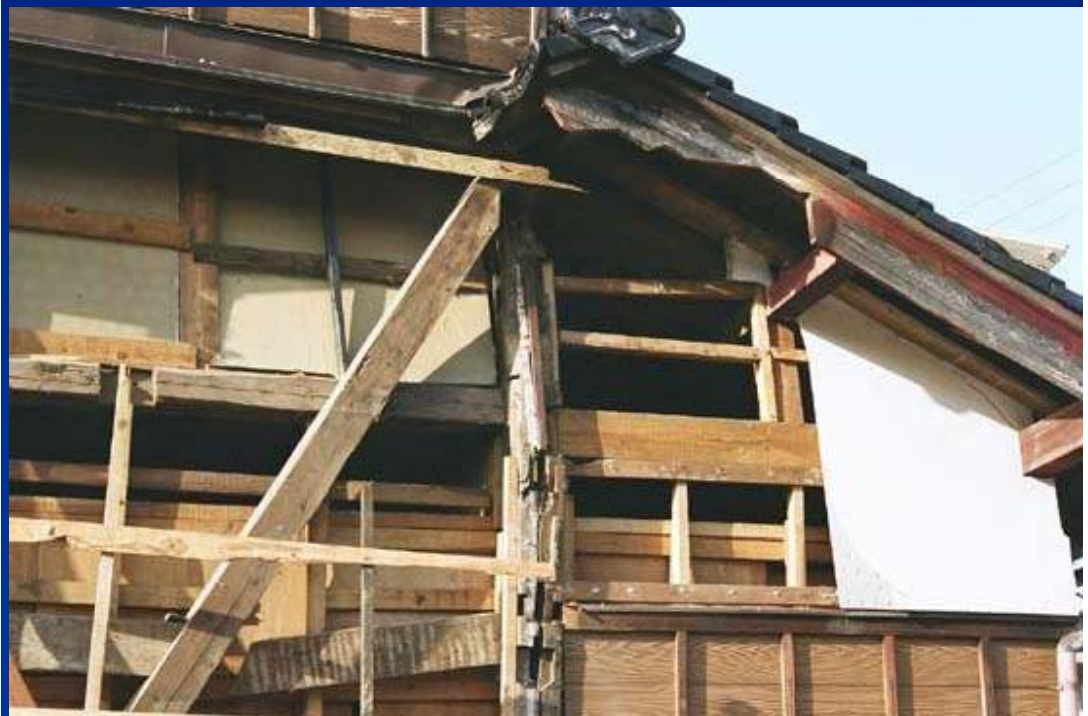
Hashiride, Wajima

Damaged townhouse

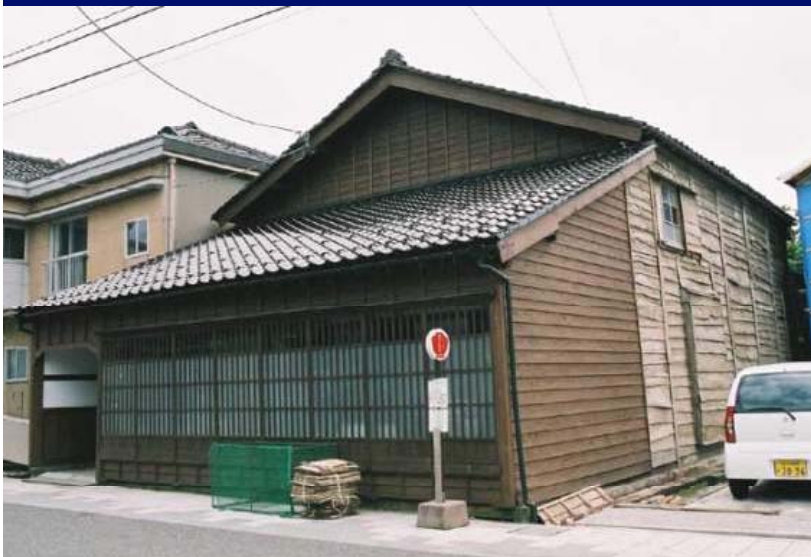
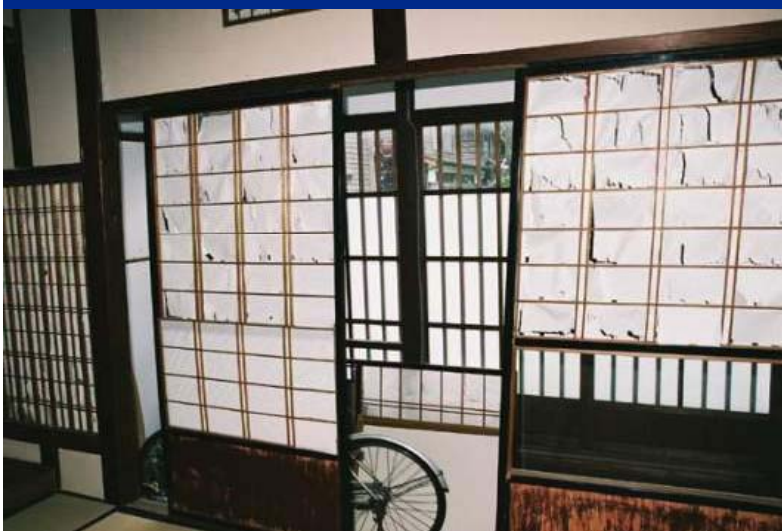
Seismic Diagnosis

direction	Horizontal load carrying capacity	Seismic Force	Seismic Index
		kN	kN	
1 st	X(NS)	29.2	103	0.28
	Y(EW)	69.4		0.67
2 nd	X(NS)	33.6	45.2	0.74
	Y(EW)	35.5		0.78

Seismic Index	
1.5 or more	Safe
1.0~1.5	Low possibility of collapse
0.7~1.0	Possibility of collapse
0.7 or less	High possibility of collapse

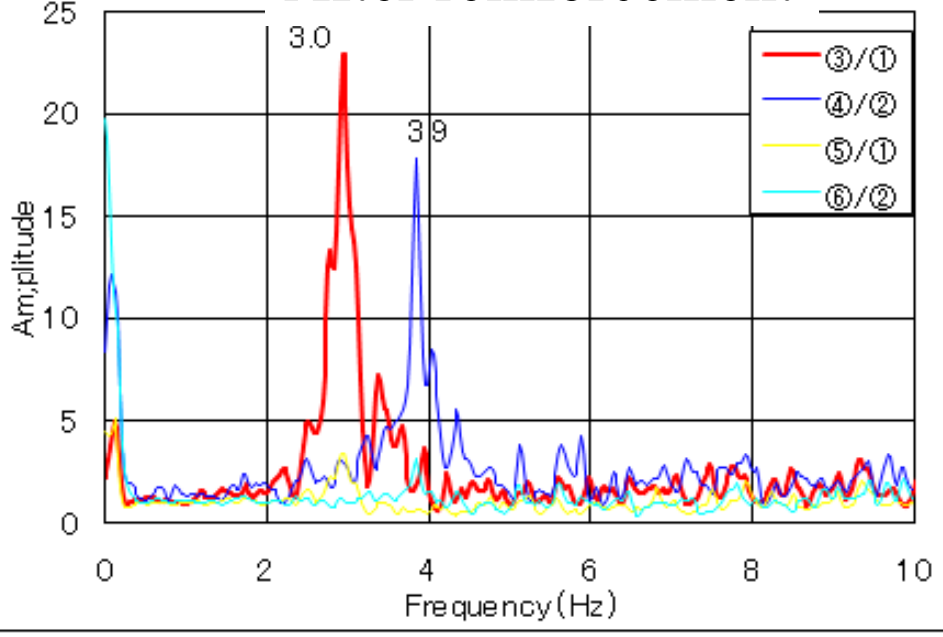
After reinforcement
 Natural frequency
 2.2Hz → 3.0Hz

- Steel bracing (temporary emergency measures)
